# THE TSUNAMI

## Alaskan Earthquake, 1964 :

### Engineering Evaluation

TECHNICAL MEMORANDUM NO. 25

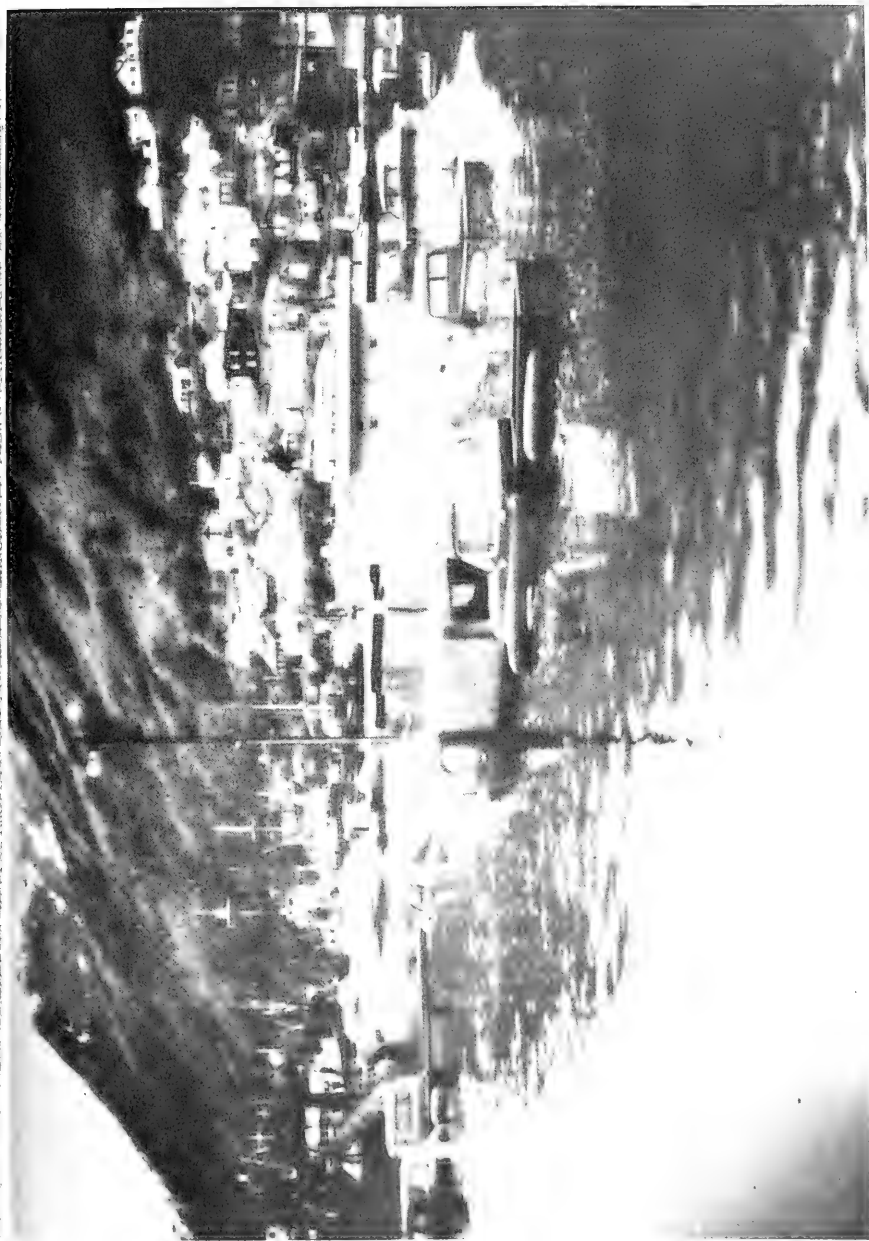
Figure 92 View of Kodiak City Waterfront and Boat Harbor at about 18:36 (AST) March 27, 1964,  
The Harbor Masters' office is flooded. (Photograph by Alf Madsen)

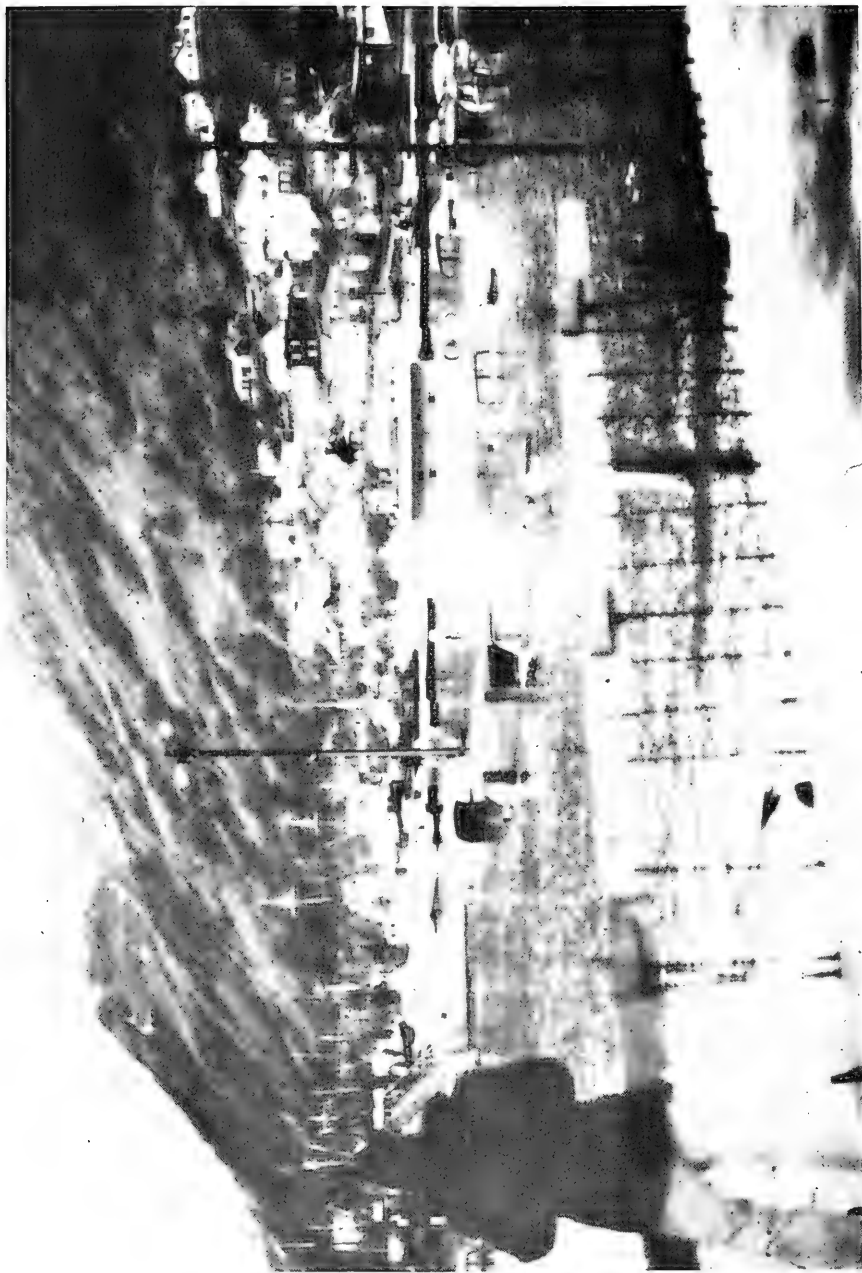
Figure 93 View from the Elks' Club Bowling Alley (under construction) Showing the Wave Still Rising at Kodiak City. Time approximately 18:38 (AST) March 27, 1964. (Photograph by Alf Madsen)

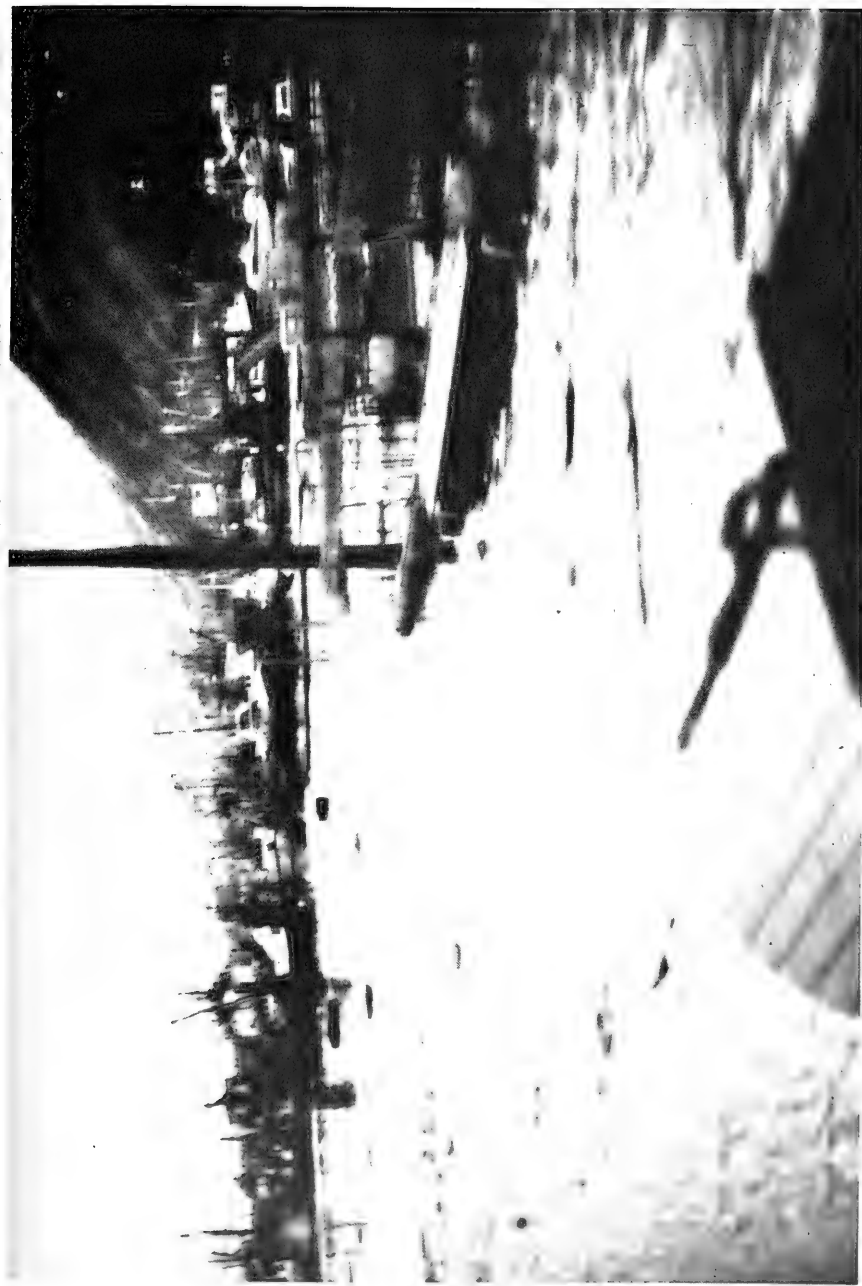
Figure 94 View of Kodiak City Boat Harbor at Approximately 18:41 (AST) March 27, 1964.  
The Tsunami Wave has now surrounded the Elks Club Bowling Alley  
(Photograph by Alf Madsen)

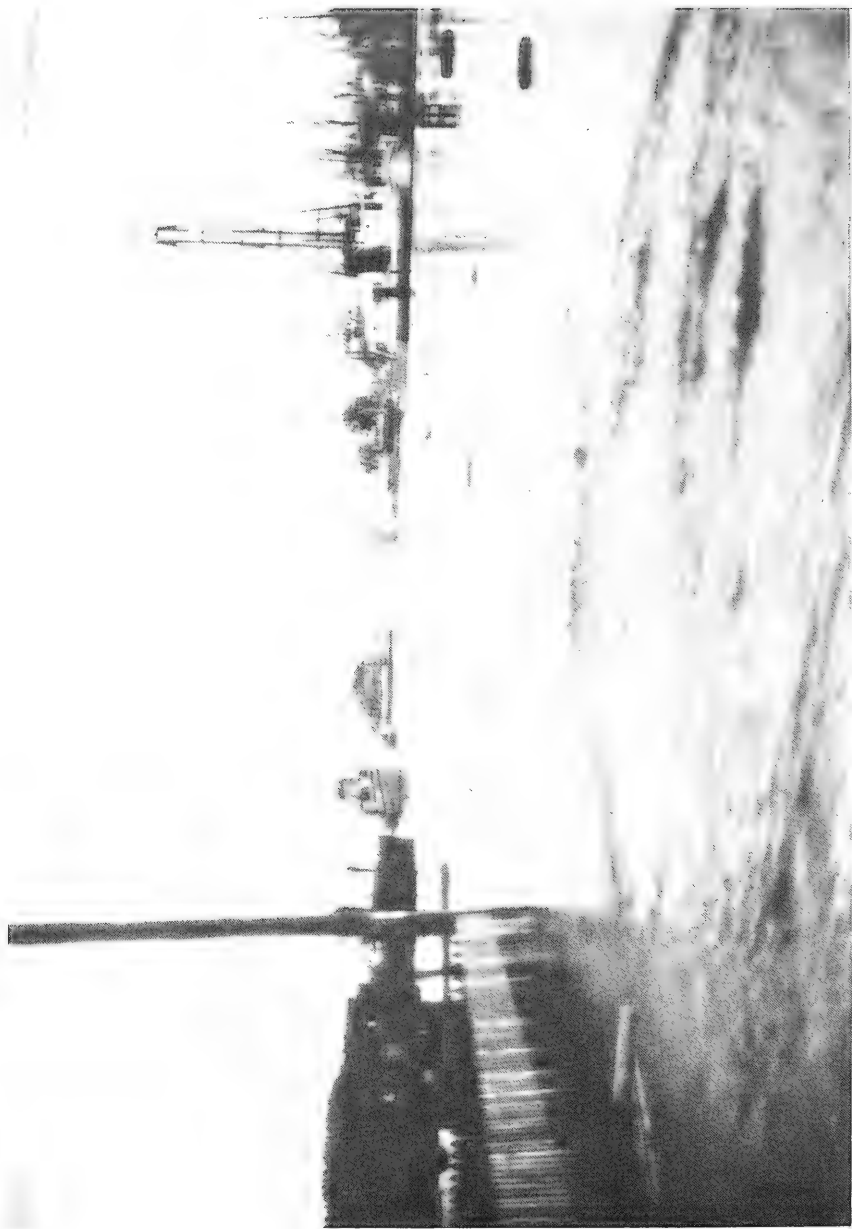
Figure 95 View (south-southwest) of the Beat Harbor at Kodiak City at Approximately 18:45 (AST) March 27, 1964. The tsunami wave is beginning to ebb. The water expanse is unbroken in the far field except by islands owing to submergence of the breakwaters.  
(Photograph by Alf Madsen)

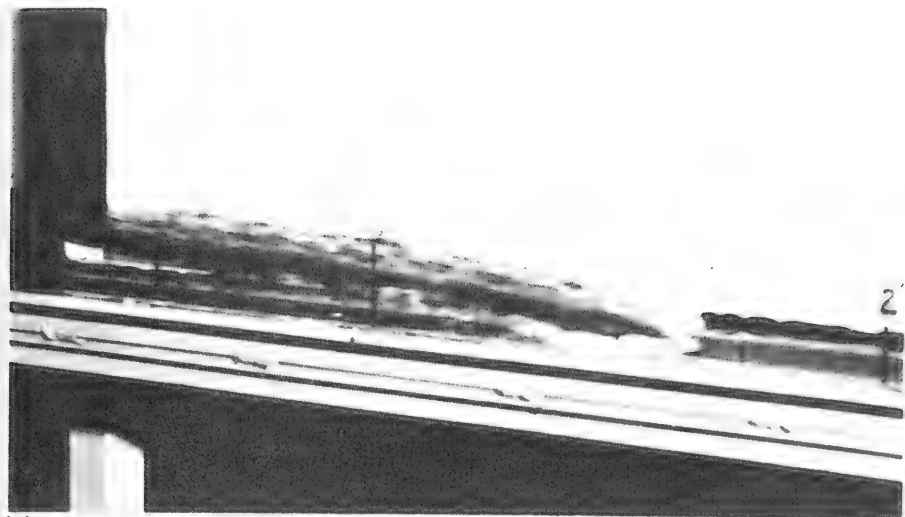
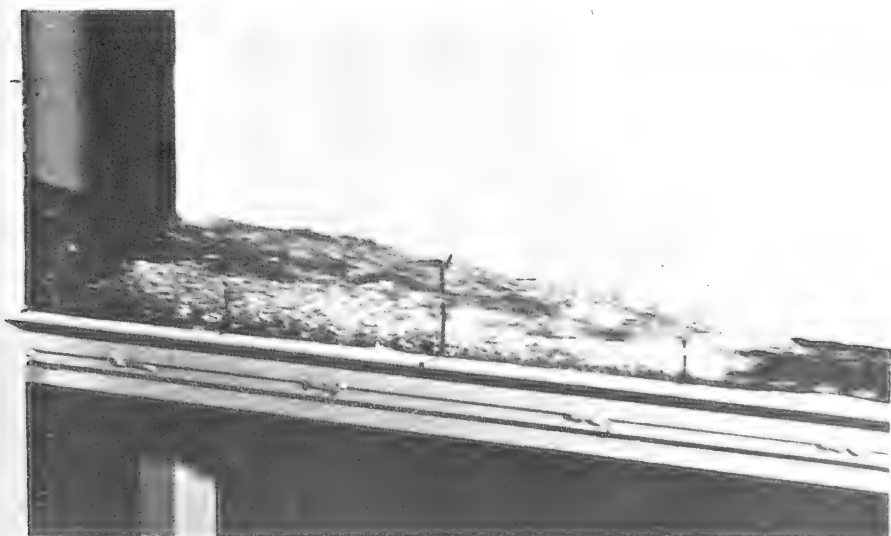
(a) SMOOTH BOTTOM

(b) ROUGH BOTTOM

Figure 99 Laboratory-Produced Surge Waves believed to be similar to the  
Tsunami Surges in Near Island Channel, Kodiak City  
(from Ralph Cross, 1966)

is reasonably supported by theory and experiment, and may be considered to apply when the depth of water in front of the surge is small compared to the total depth  $d_s$  of the surge. Adopting  $d_s \approx 37$  feet,  $u_s$  is calculated to be 69 feet per second or 47 miles per hour. The Fremains had estimated the water speed in the Near Island channel as 50 miles per hour (Chance, 1968).

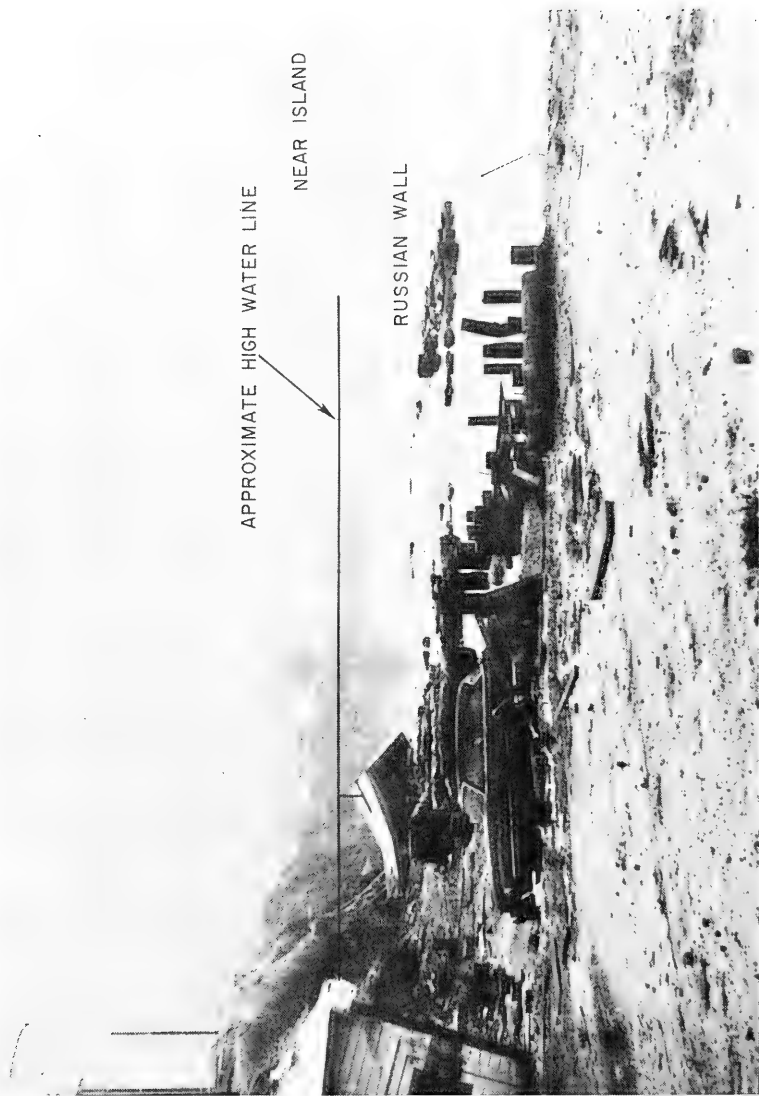
Figure 101 (a) Skeleton-like timber pilings mark former site of Cannery in the view northeast along Near Island Channel. The Russian Wall survived the Tsunami.  
(Photograph by Dolores Roguszka)

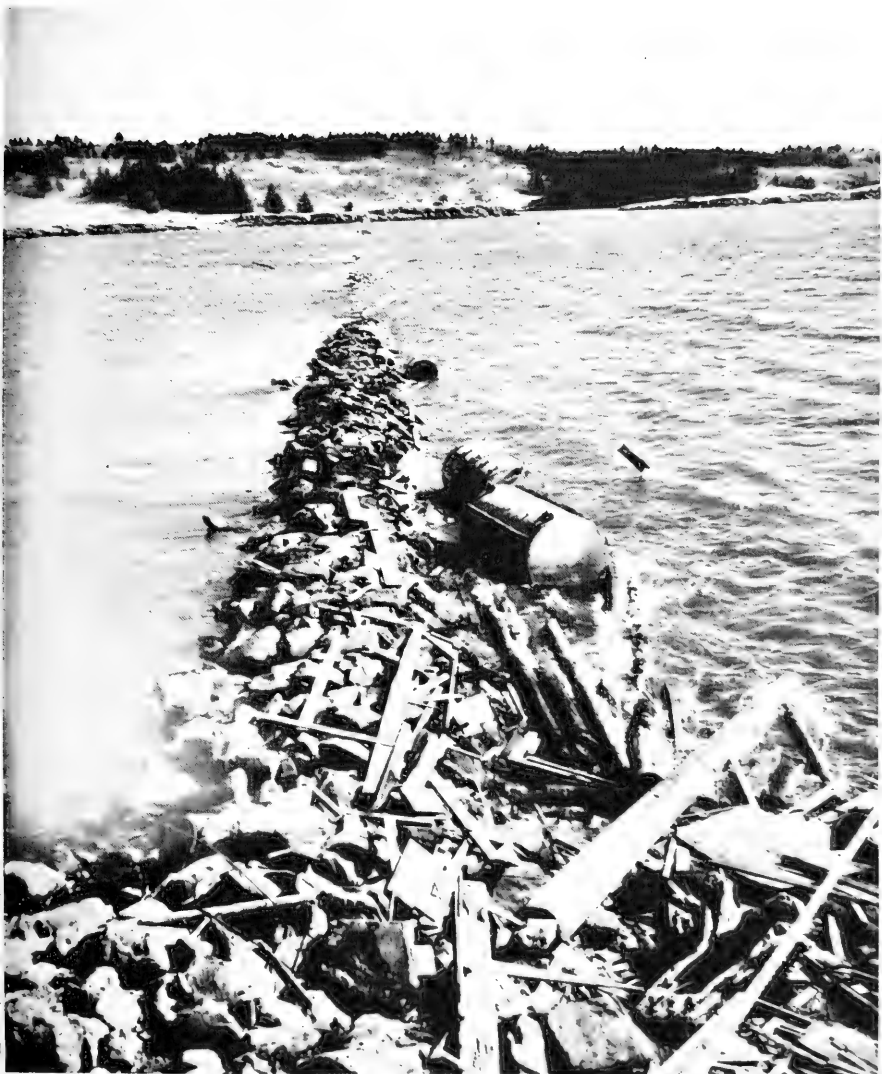
Figure 102 Southwest Breakwater at Kodiak shortly after the Earthquake  
with some of the battered remains of the King Crab Cannery  
(Photograph by U. S. Army)

Damage to the breakwaters was partly due to compaction settlement caused by the tremors and partly due to the tsunami. Figure 89 shows typical sections of the breakwaters as they were measured after the quake, as well as cross sections of the rebuilt breakwaters (U. S. Army Corps of Engineers, Anchorage, Alaska). The exact weight of the cover-layer stones and the core material of the breakwater are not known. However, to judge from Figure 102, the armor stones were too light to resist any great degree of overtopping.

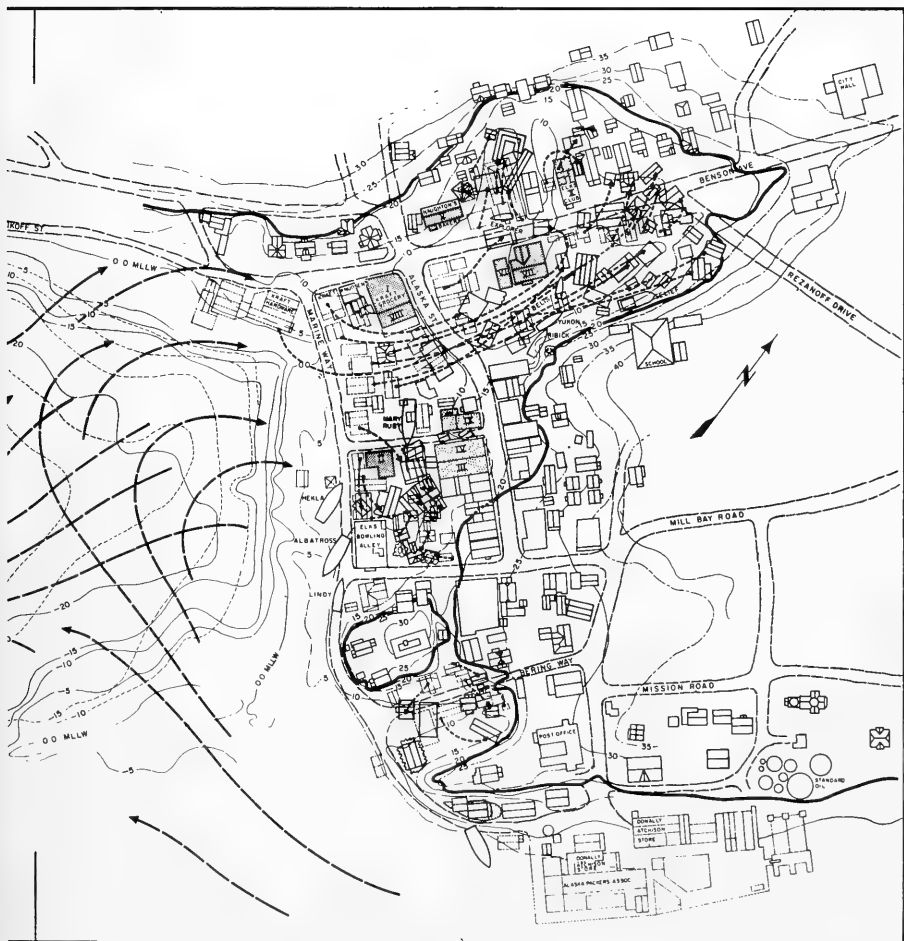
Figure 103 Map of Kodiak City, Boat Harbor and Inner Anchorage after the Earthquake and Tsunami. (Based on data from J. Barr, Kodiak; U. S. Army Corps of Engineers, Anchorage; photographs of Alf Madsen, Kodiak; and U. S. Navy Station, Kodiak)

Figure 103 shows also the probable paths of buildings in Kodiak which were either lifted off their foundations by this "third" wave or were battered to pieces by the ramming effect of boats and flotsam. Because most people left the town after the "second" wave, and because of darkness, little is known in detail about the damage done downtown by the third and succeeding waves except the evidence found next morning. As Figure 90 shows and Figure 38a indicates, the highest wave was yet to come. This wave, probably the "fourth", was a composite of the second tsunami crest (Figure 38c), the third shelf oscillation, sundry local oscillations and the rising high tide. The effect was undoubtedly similar to that of the "third" wave, and whatever had been weakened by the "third" became prey for the "fourth". The torrents of water in the channel made roaring and sucking noises, and horrible grinding sounds accompanied the attrition of buildings and structures during the night (Norton and Haas, 1966; Chance, 1968).

James Barr, consulting engineer, Kodiak, surveyed the damage for the Office of Civil Defense shortly after the quake; his rough results are corrected and incorporated in Figure 103. The excellent photographs of Alf Madsen have greatly assisted the preparation of this map.

Damage in the downtown area is shown in the series of photographs, Figures 104 to 106. On these and on the map (Figure 103), several buildings are marked with identifying numbers I to X. These buildings, although lying in the path of the tsunami, were unmoved, but all suffered damage and some were unsalvageable. The type of structure in these buildings and the extent of damage are summarized in Table V. The waves caused minor erosion of roads and sidewalks downtown.

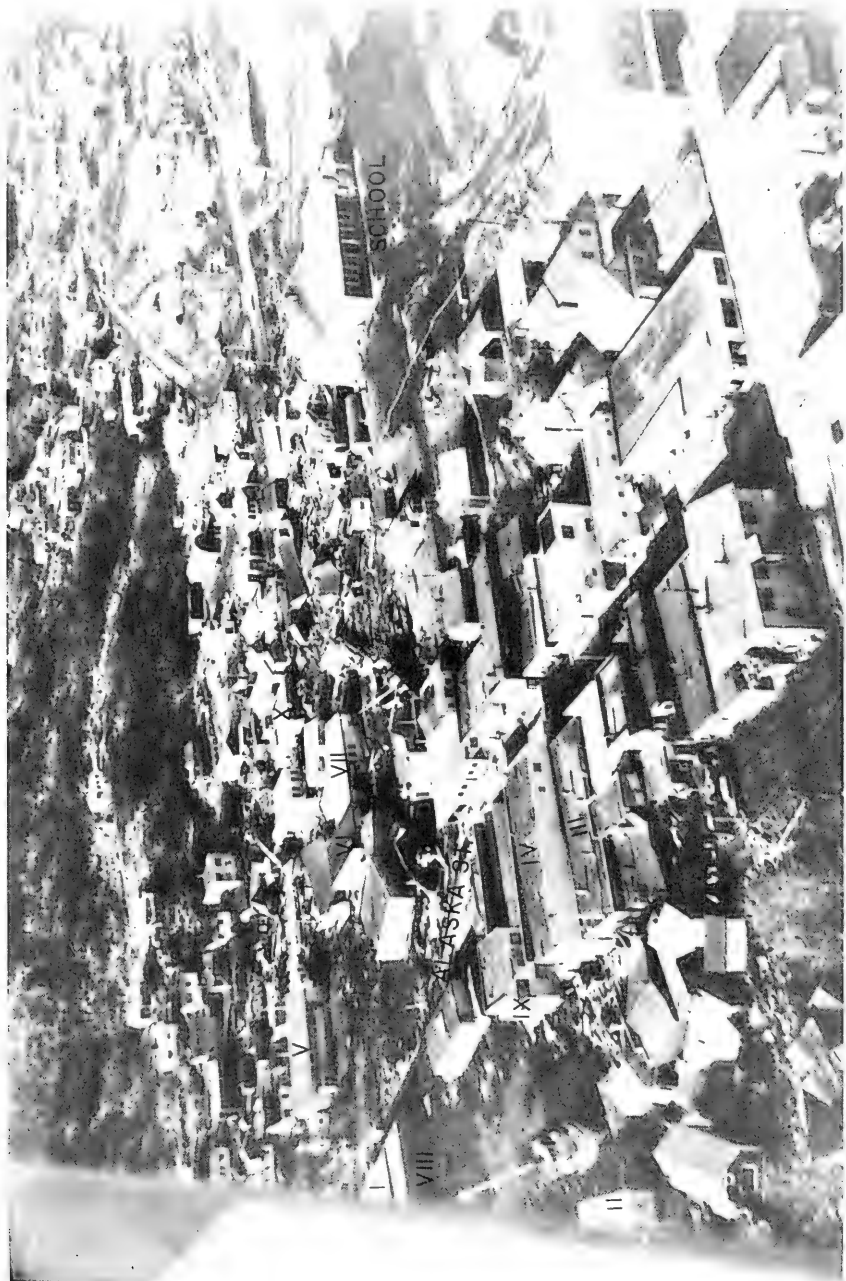
Figure 104 Tsunami Damage in Downtown Kodiak. (Photograph by Alf Madsen)

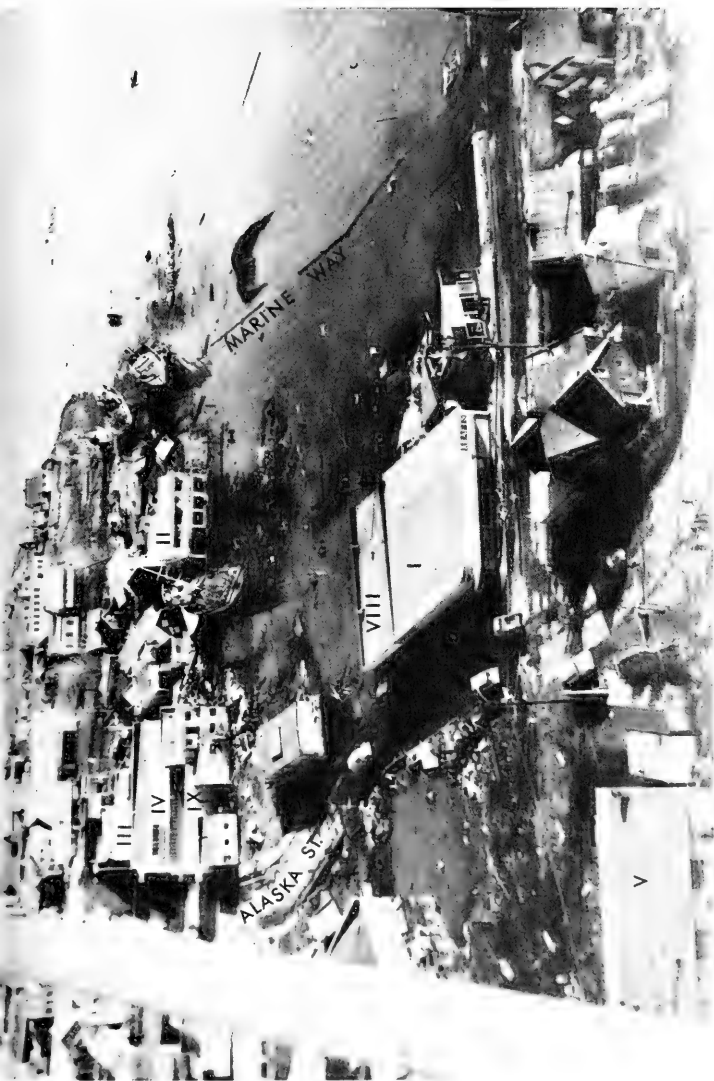
Figure 105 Tsunami damage in downtown Kodiak. Some cleanup has been done.  
(Photograph by Alf Madsen)

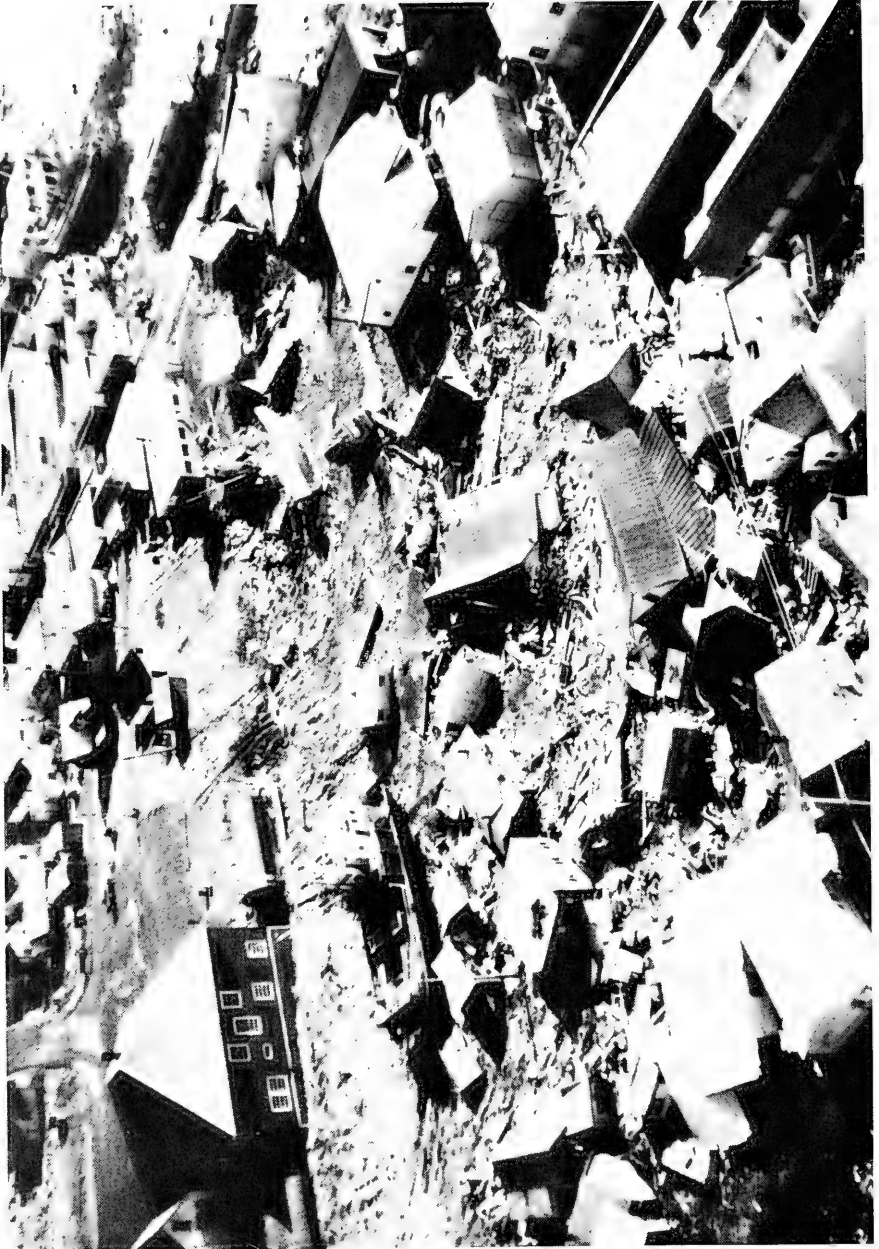
Figure 106 View of part of Kodiak City showing destruction wrought by the Tsunami  
(Photograph by Alf Madsen)

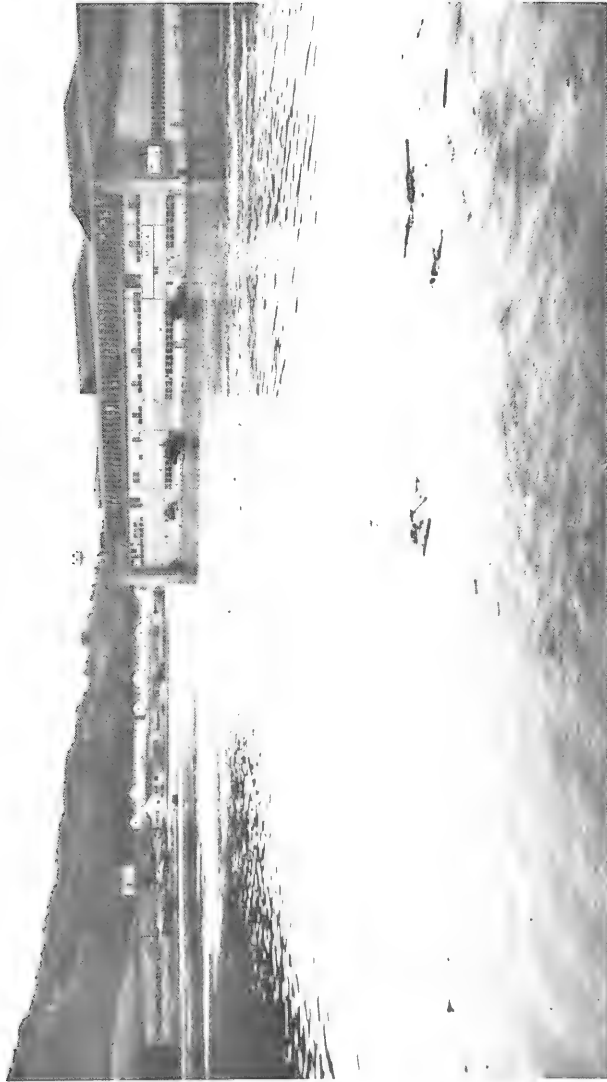
Figure 112 View (northwest) of Inundation from the First Tsunami Wave in Womens Bay, Kodiak at about 18:35 (AST) March 27, 1964, showing flooding of Hangar No. 1. (Photograph by U. S. Navy, Kodiak)

As at Kodiak City, the first large wave occurred as a fast-rising tide, effectively the result of gradual flooding from a previous situation of only minor withdrawal if any. The first wave was photographed in the sunset light and the extent of flooding is shown in Figures 111 and 112. These photographs show inundation at the head of Womens Bay around the hangars of the Navy air terminal (Figure 113). In Figure 114 partial recession of the wave has taken place: leaving deposits of flotsam on the seaplane ramps. Figure 113, based on an original drawing of the Nyman Peninsula by the U. S. Navy, Kodiak (Kachadoorian and Plafker, 1967) shows the general extent of flooding of the Navy Base area. The locations at which the photographs of Figures 111, 112, and 114 were taken, as well as the locations of other photographs to which we shall refer, are also shown.

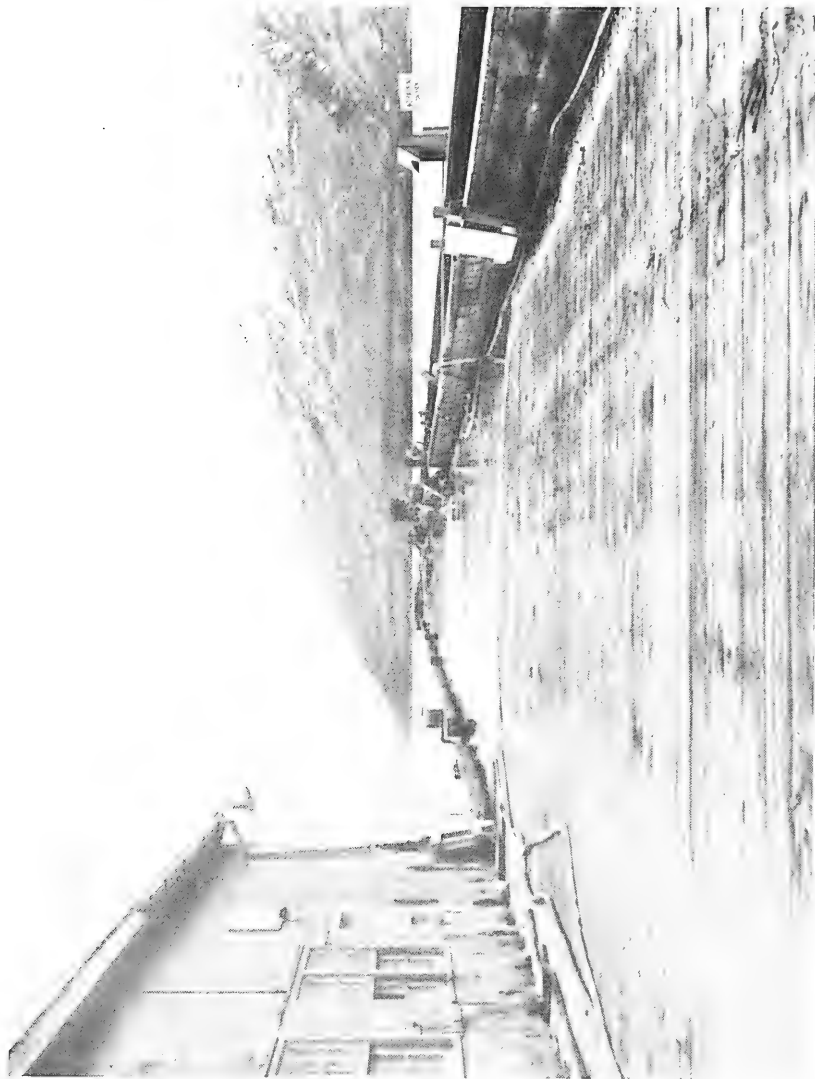
Figure 116 The Fuel Pier at the Naval Station, Kodiak, inundated by Postquake High Tide.  
(Photograph by U. S. Navy)

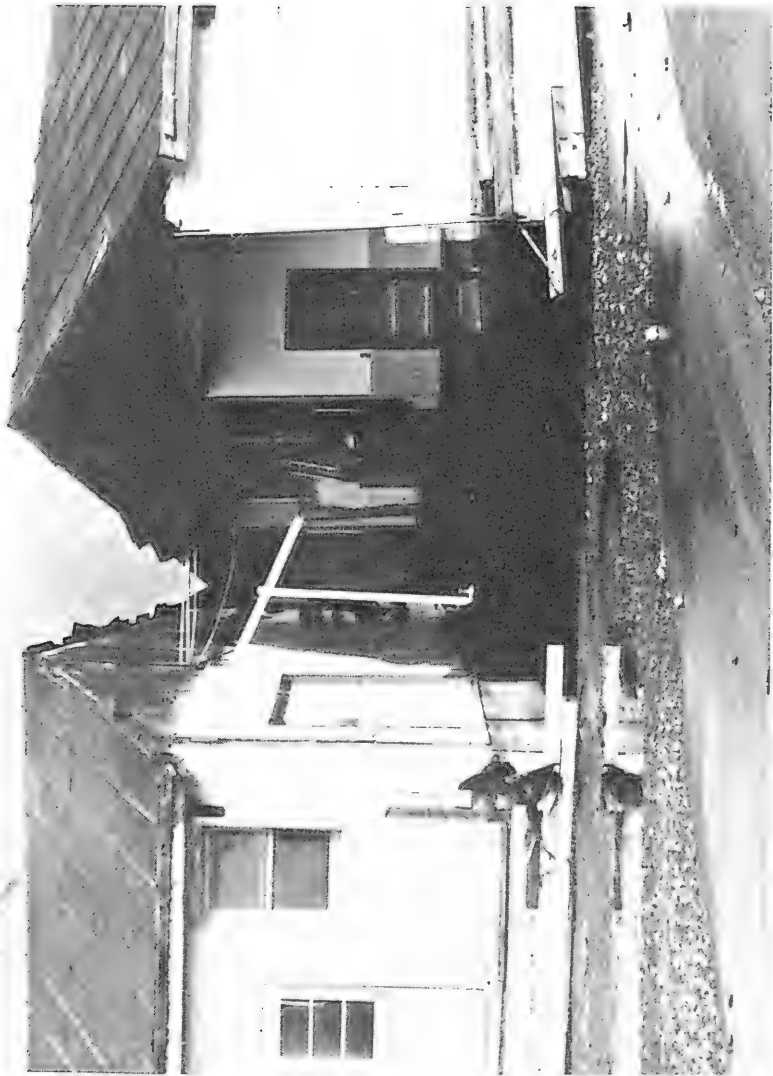
Figure 118 Damaged Hobby Shop at the Naval Station, Kodiak (Photograph by U. S. Navy)

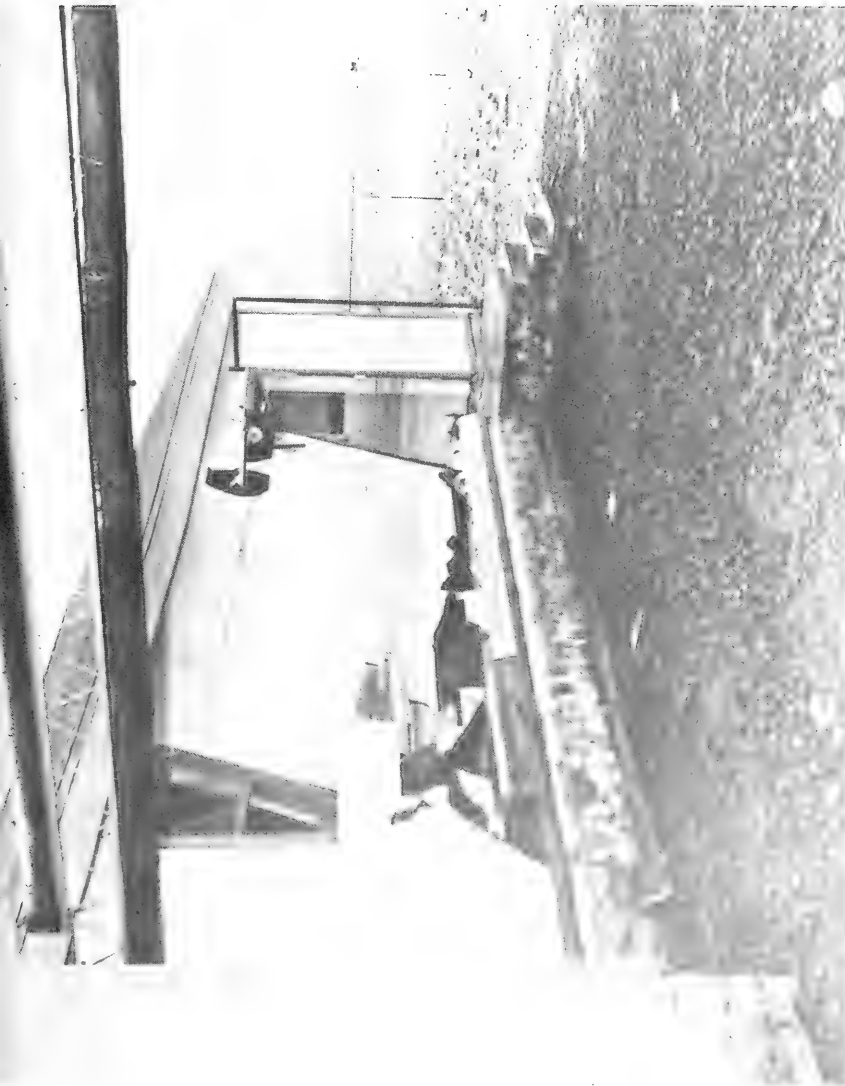
Figure 119 The Ground Electronics Building at Kodiak Naval Station; apparently imploded under Hydrostatic Water Pressure (Photograph by U. S. Navy)

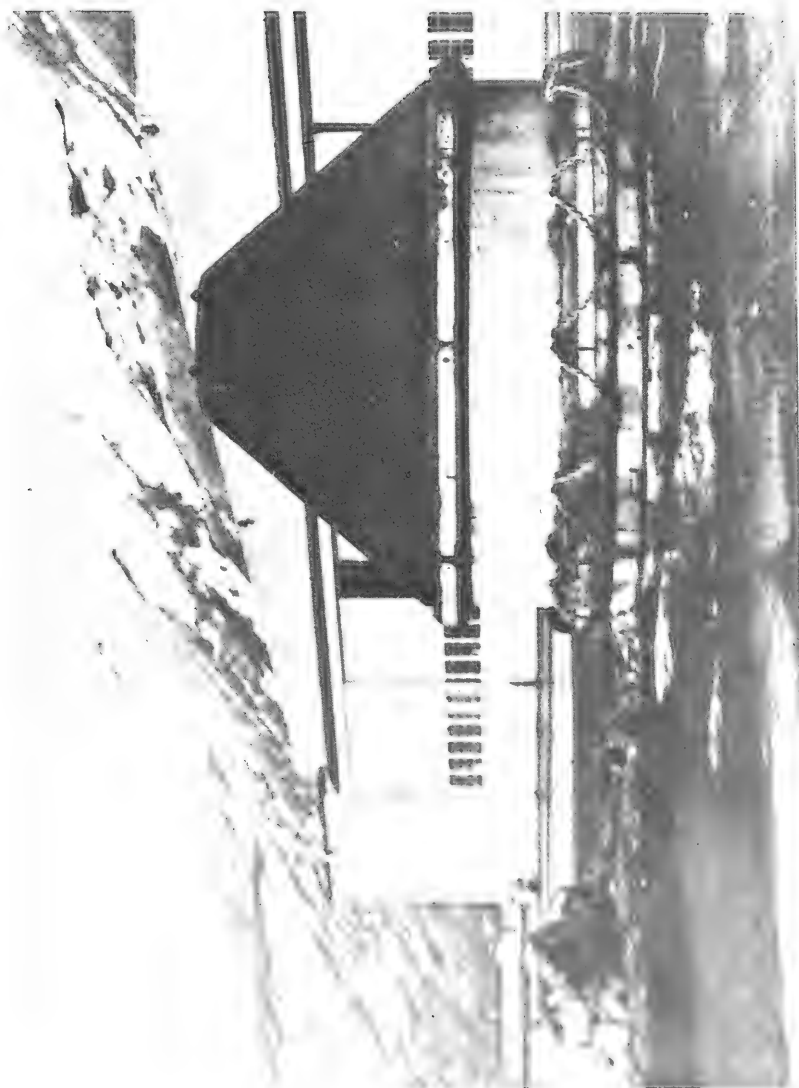
Figure 120 Mooring Buoy Washed Ashore by Seismic Sea Waves, Kodiak Naval Station  
(Photograph by U. S. Navy)

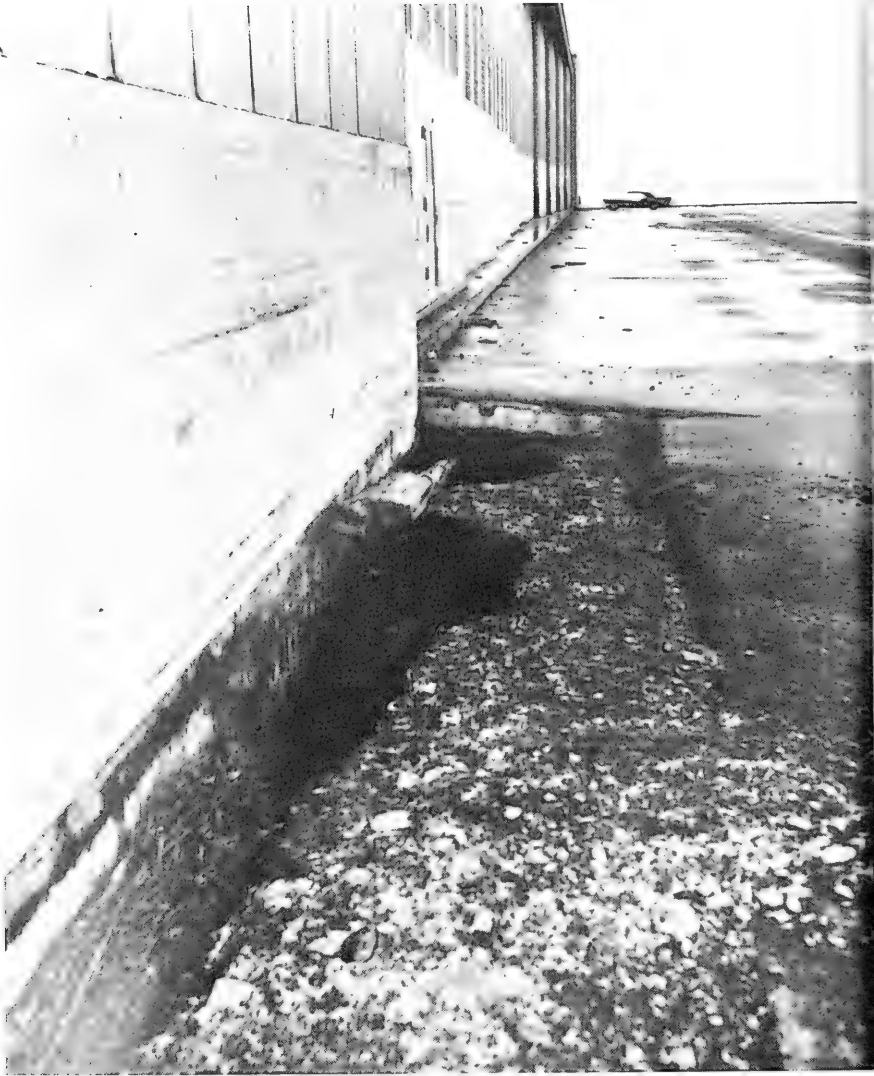
Figure 121 Evidence of Settlement of Backfill Material below Pavement Level, adjacent to the foundation of a Hangar at Kodiak Naval Station. (Photograph by U. S. Navy)

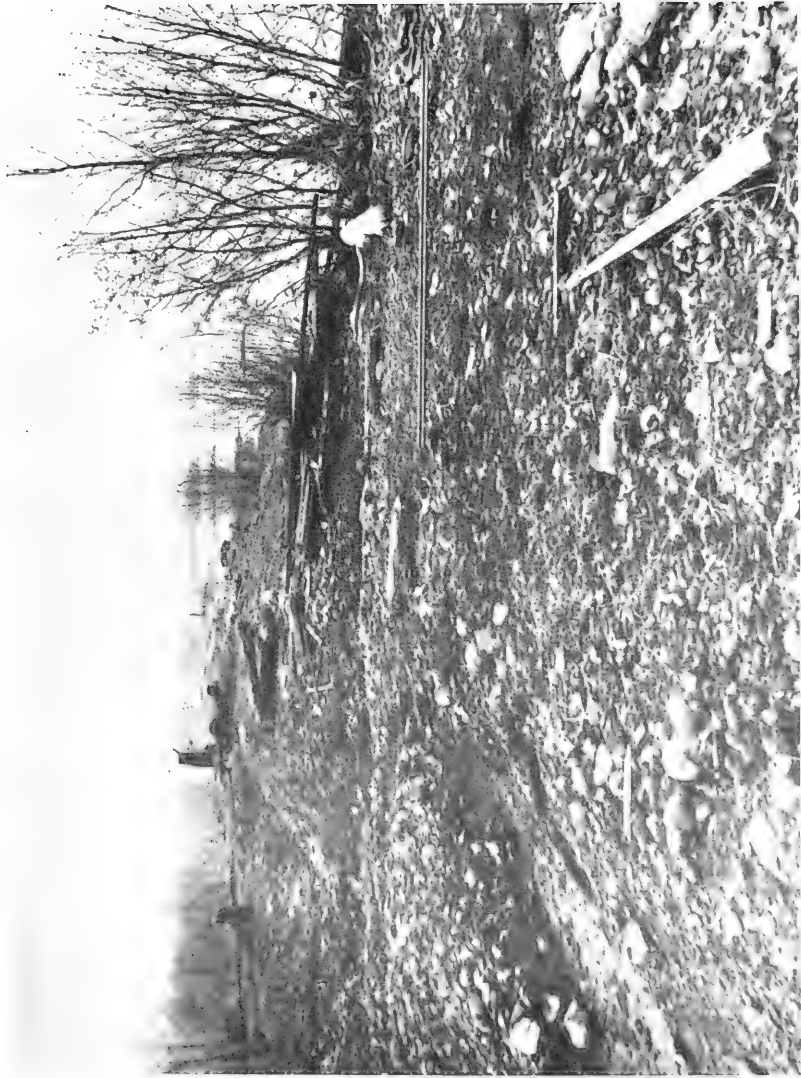
Figure 123 Damaged Road on the Deltaic Area at the Southwest Head of Womens Bay  
(Photograph by U. S. Navy)

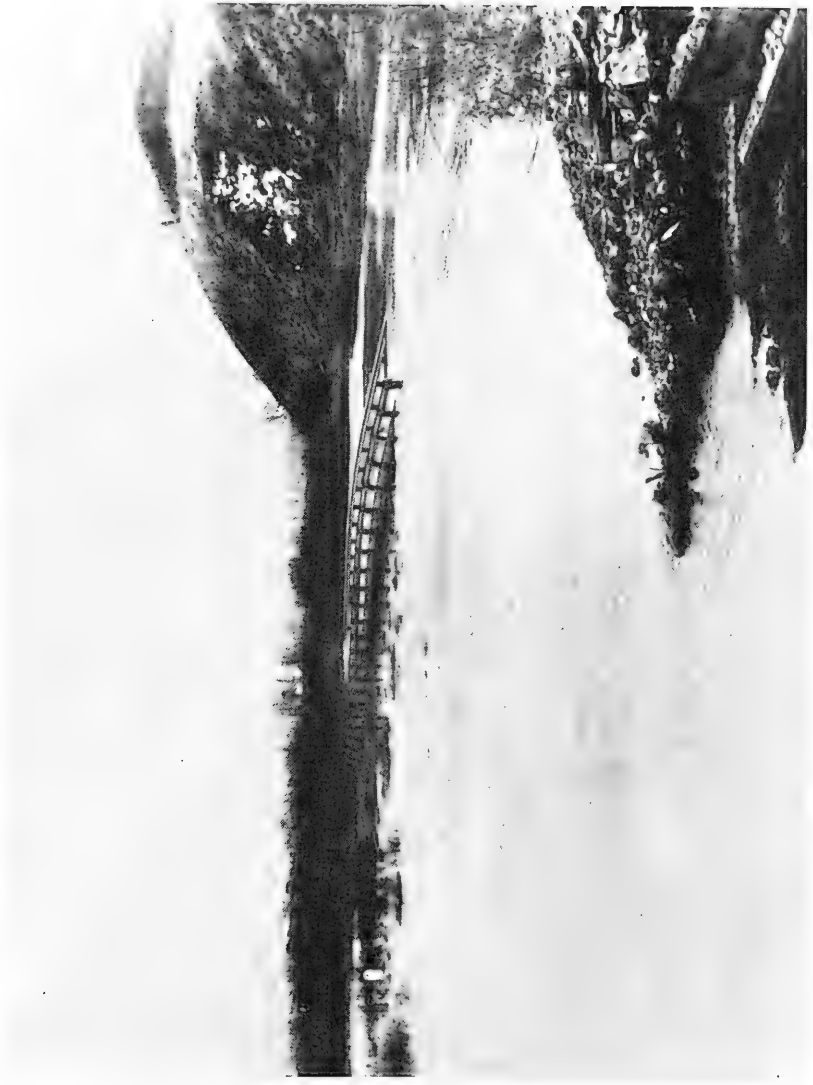
Figure 124 Damaged Road Bridge on the Deltaic Area at the Southwest Head of Womens Bay  
(Photograph by U. S. Navy)

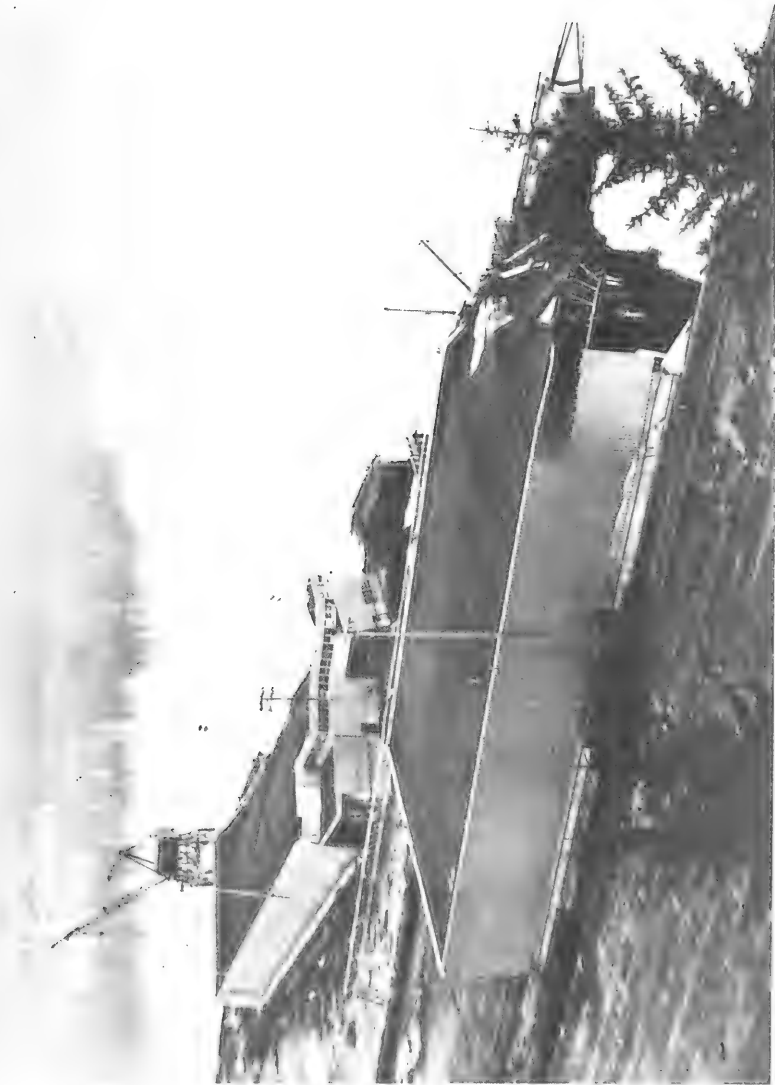
Figure 136 Remains of the Alaska Railroad Docks at the South End of Seward after the Earthquake and Seismic Sea Waves of March 27, 1964. (Photograph by Irvin Cook, Anchorage)

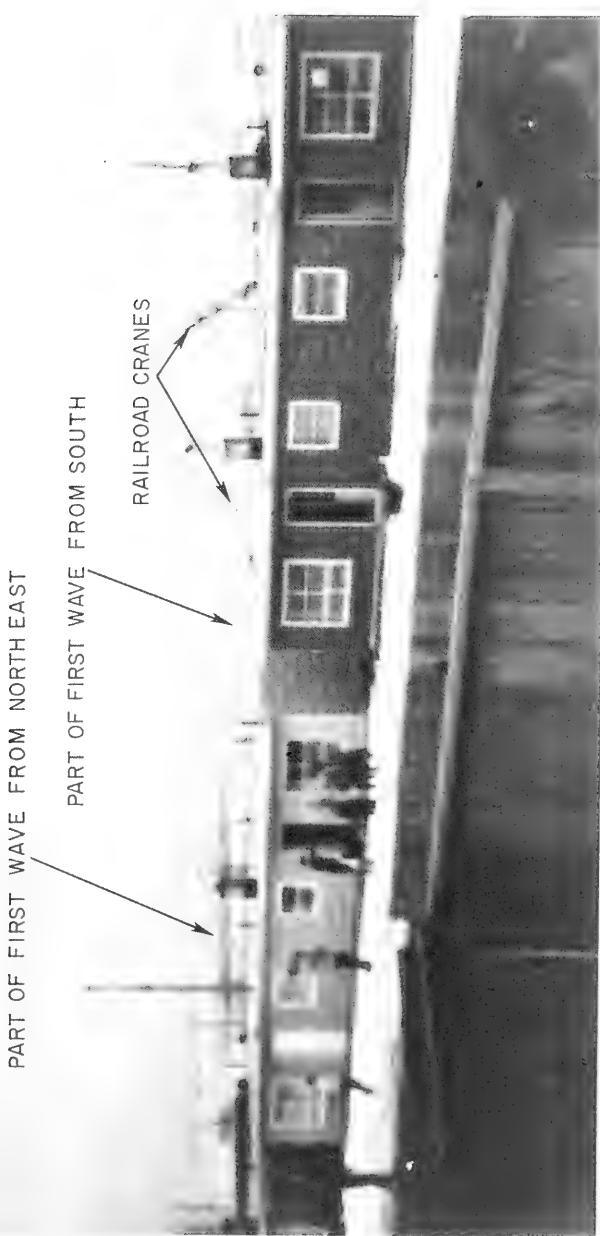
Figure 142 (b) View looking east-northeast from Location A. North-moving wave crest (near railroad cranes) appears to be crossing through wave(s) approaching from east-northeast. (Photograph by Terrel Schenk, Seward)

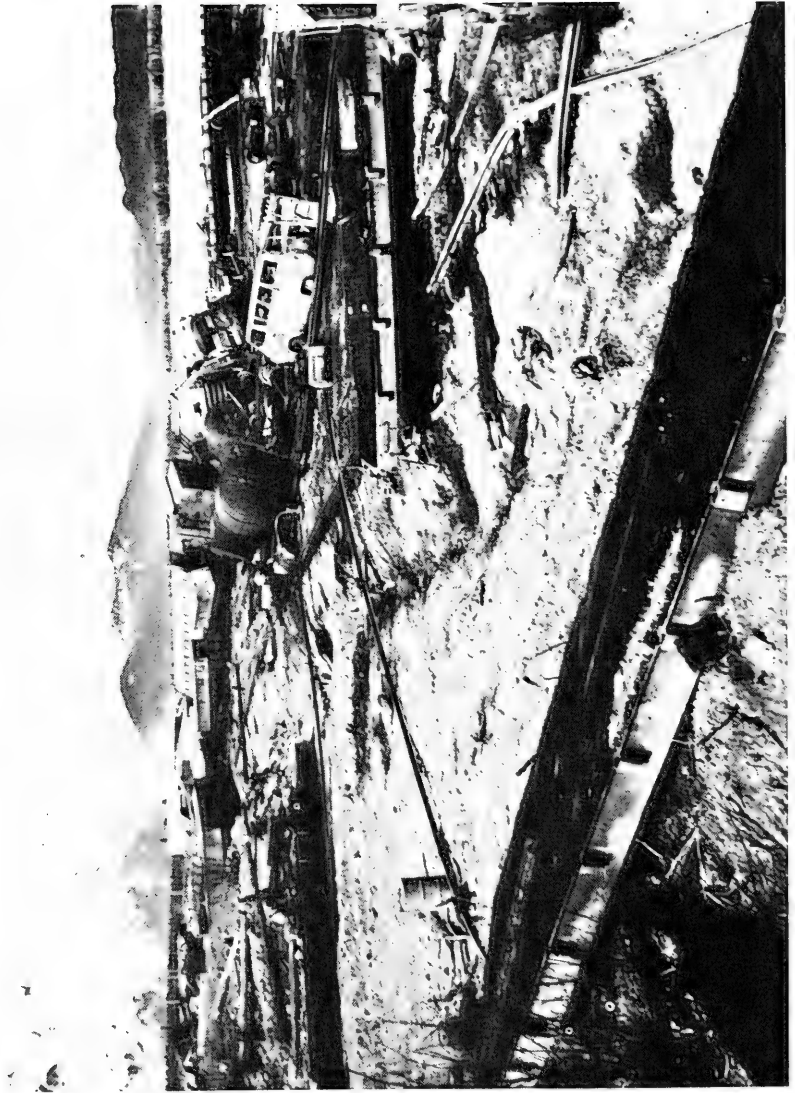
Figure 147 Wave damage in the Alaska Railroad marshalling yard. View looking northeast.

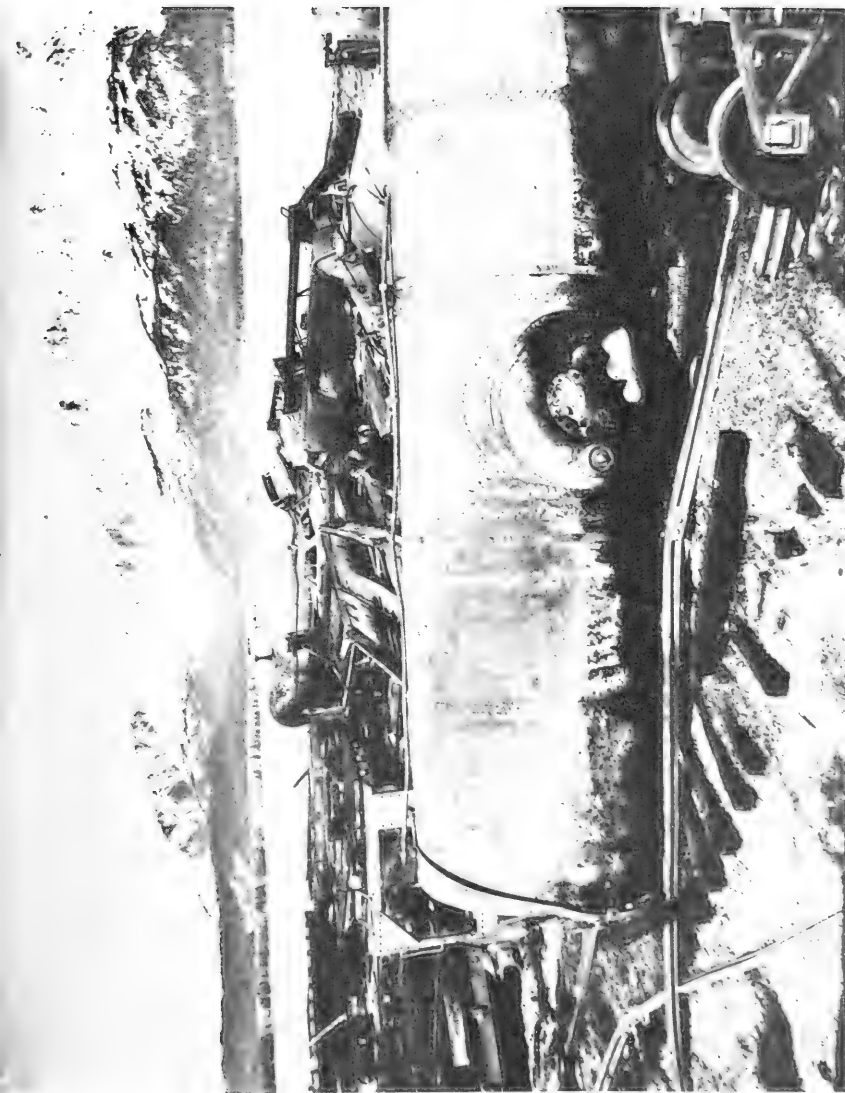
Figure 146 Wave damage in the Alaska Railroad marshalling yard. (Photograph by U. S. Army)
